False Joint

D65

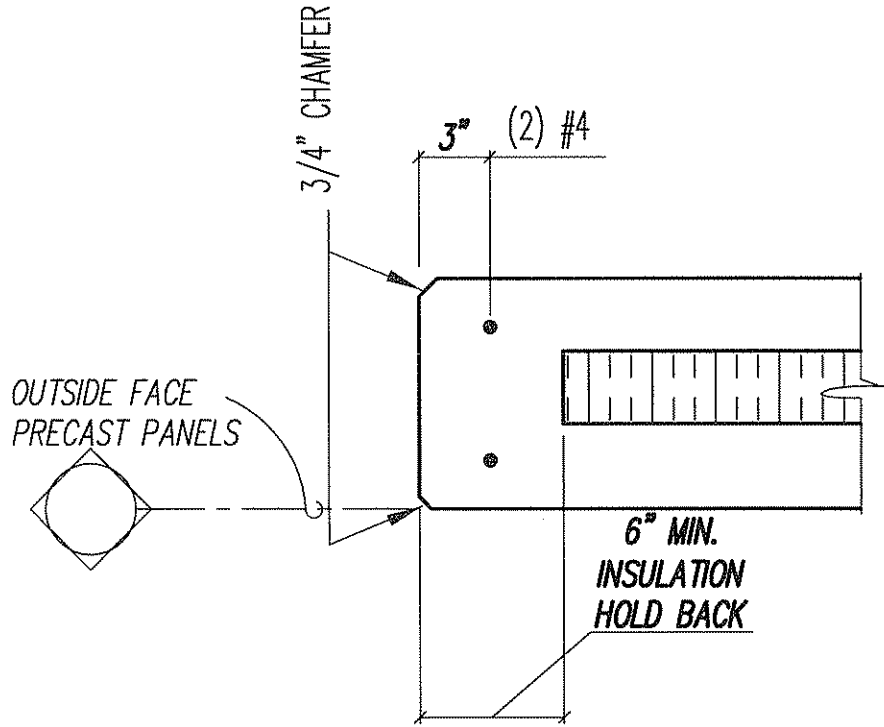
DETAIL NO.:  
**D70**

STANDARD DESCRIPTION:  
*3/4" Chamfer on Both Faces at Butt Corner*

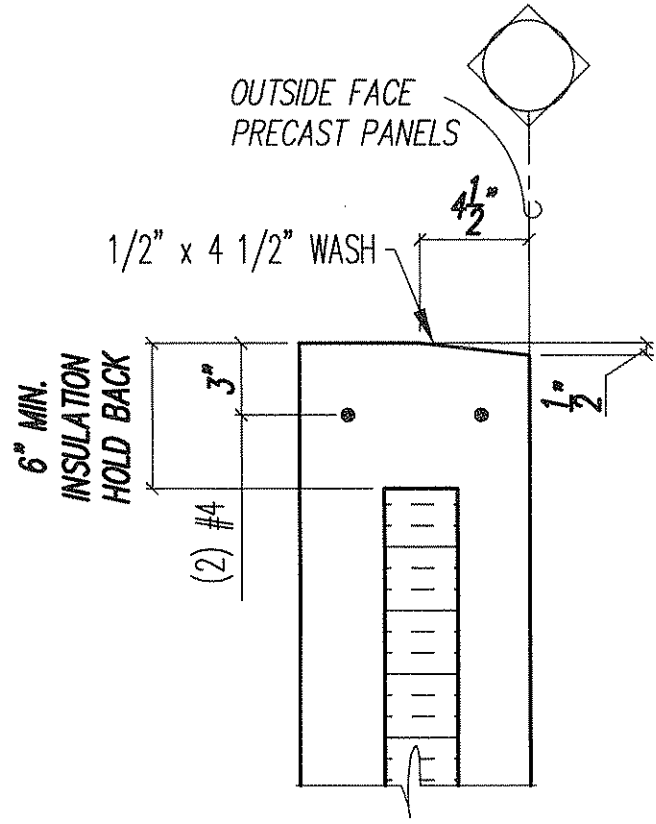
DETAIL NO.:  
**D72**

STANDARD DESCRIPTION:  
*Typical Wash at Opening Sill*

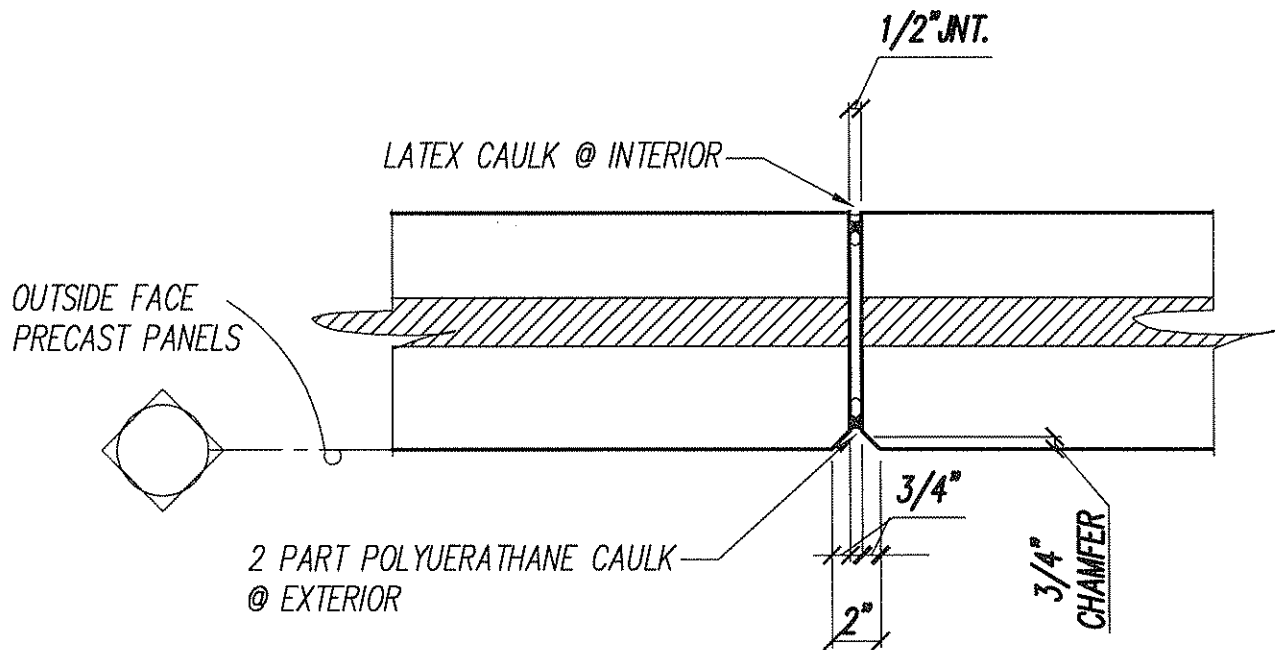
DETAIL NO.:  
**D73**

STANDARD DESCRIPTION:  
*Typical Panel Joint*

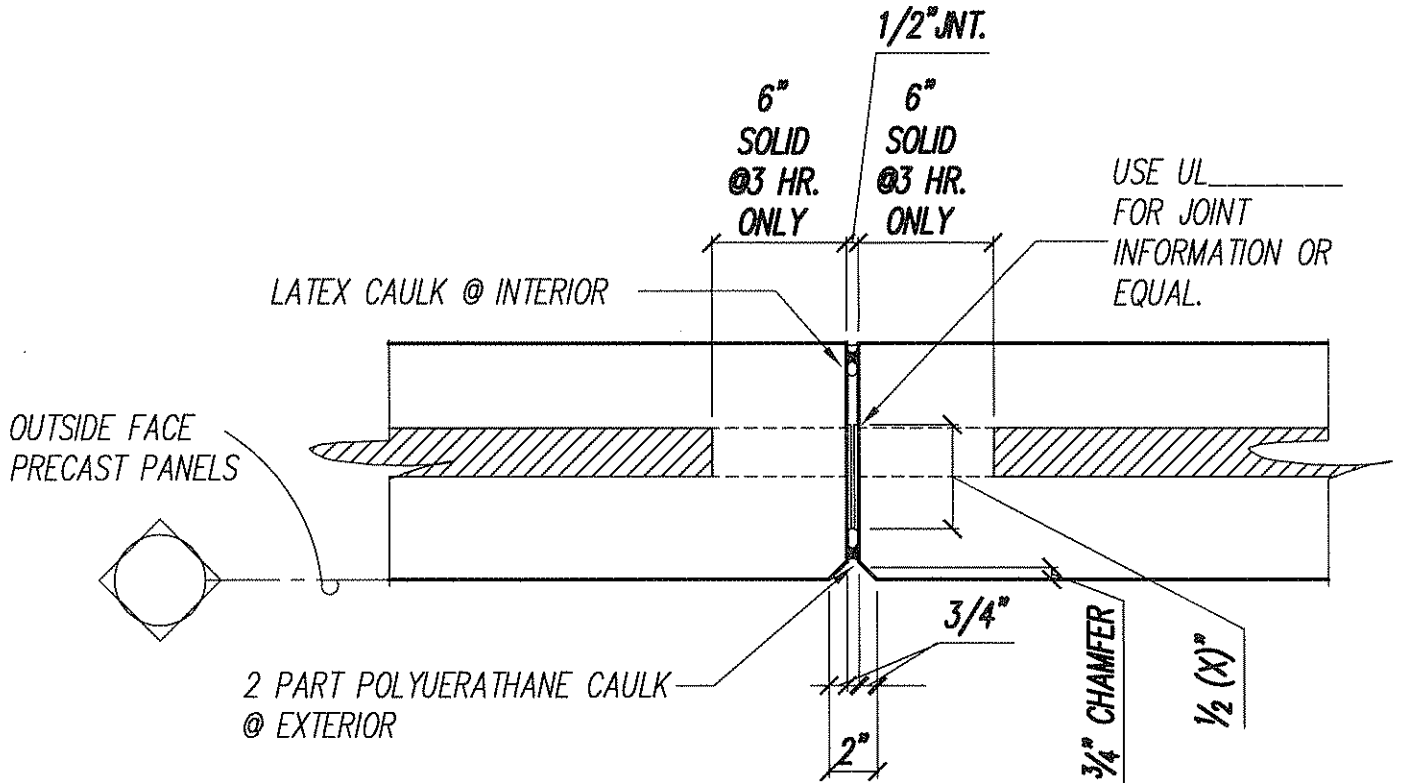
DETAIL NO.:  
**D74**

NOTE: UL-923 IS ATMI PRECAST'S APPROVED UL PANEL FOR 3 HOUR RATING.

STANDARD DESCRIPTION:  
*Typical Rated Panel Joint*
